Slight Breaks, Major Headaches: Wind Energy Converter Failure Analysis Vignettes

Rachel Wittman, John Hasier | Intertek Engineering Consulting | Asset Integrity Management

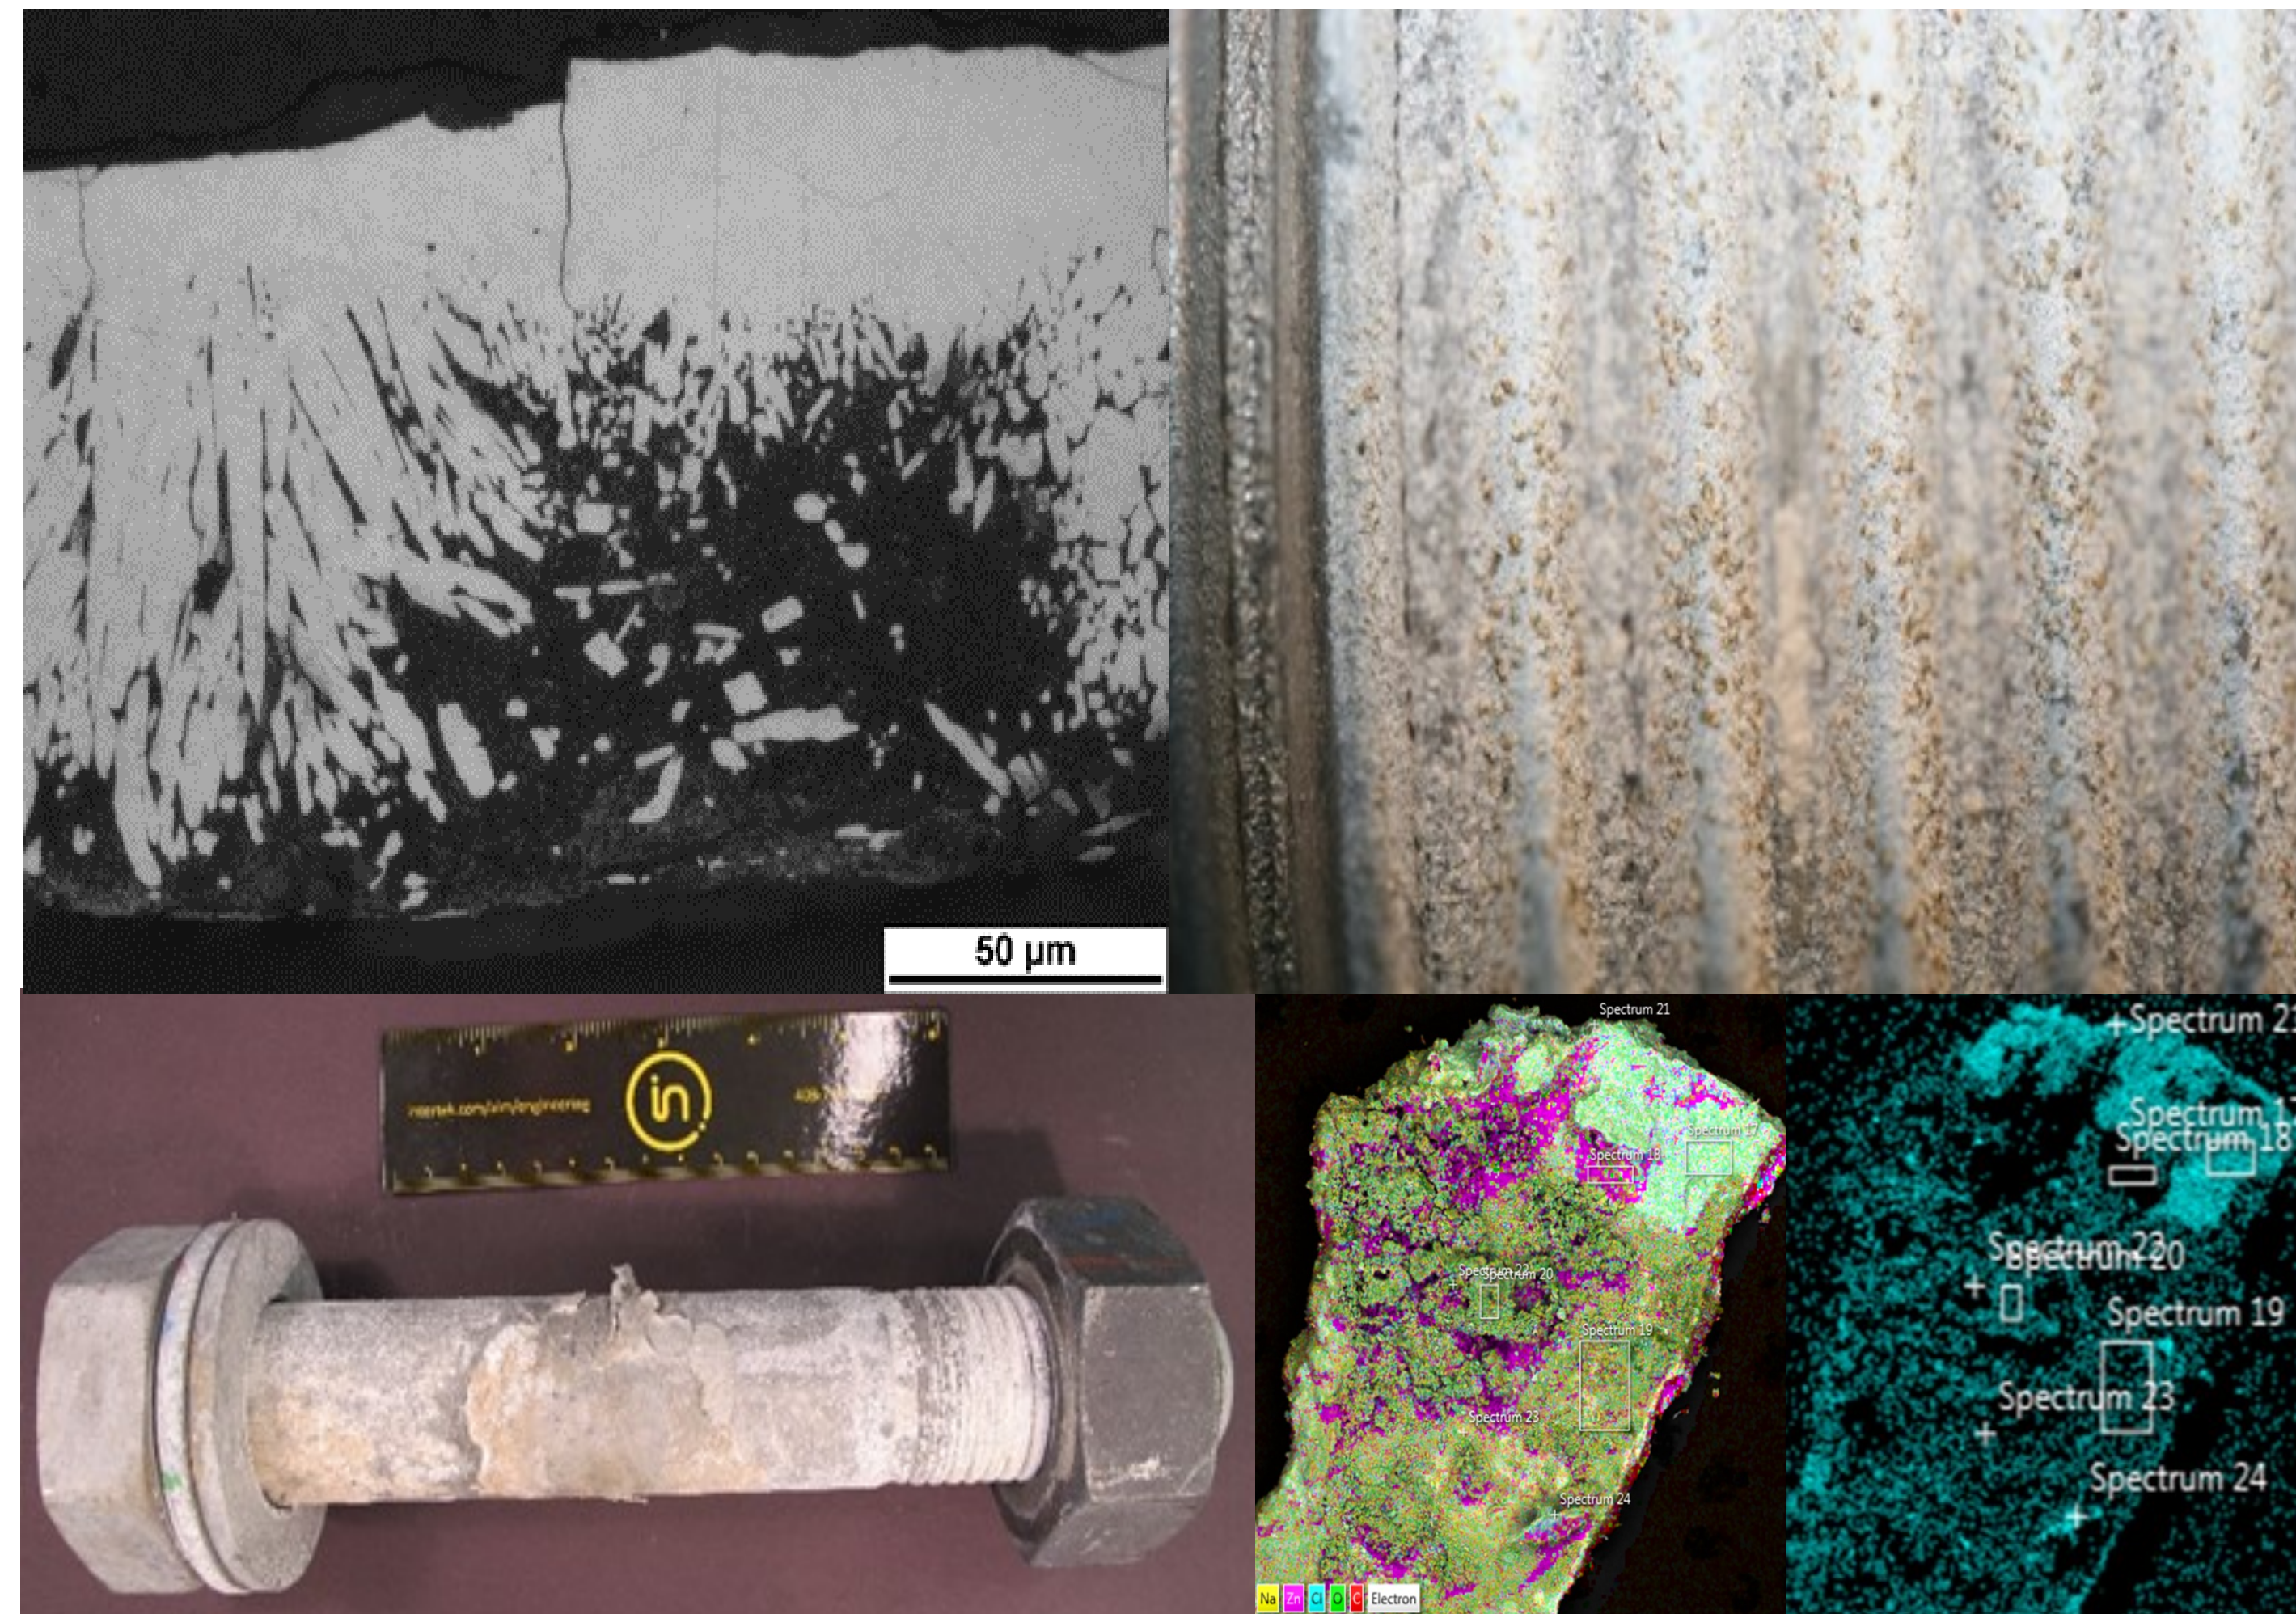
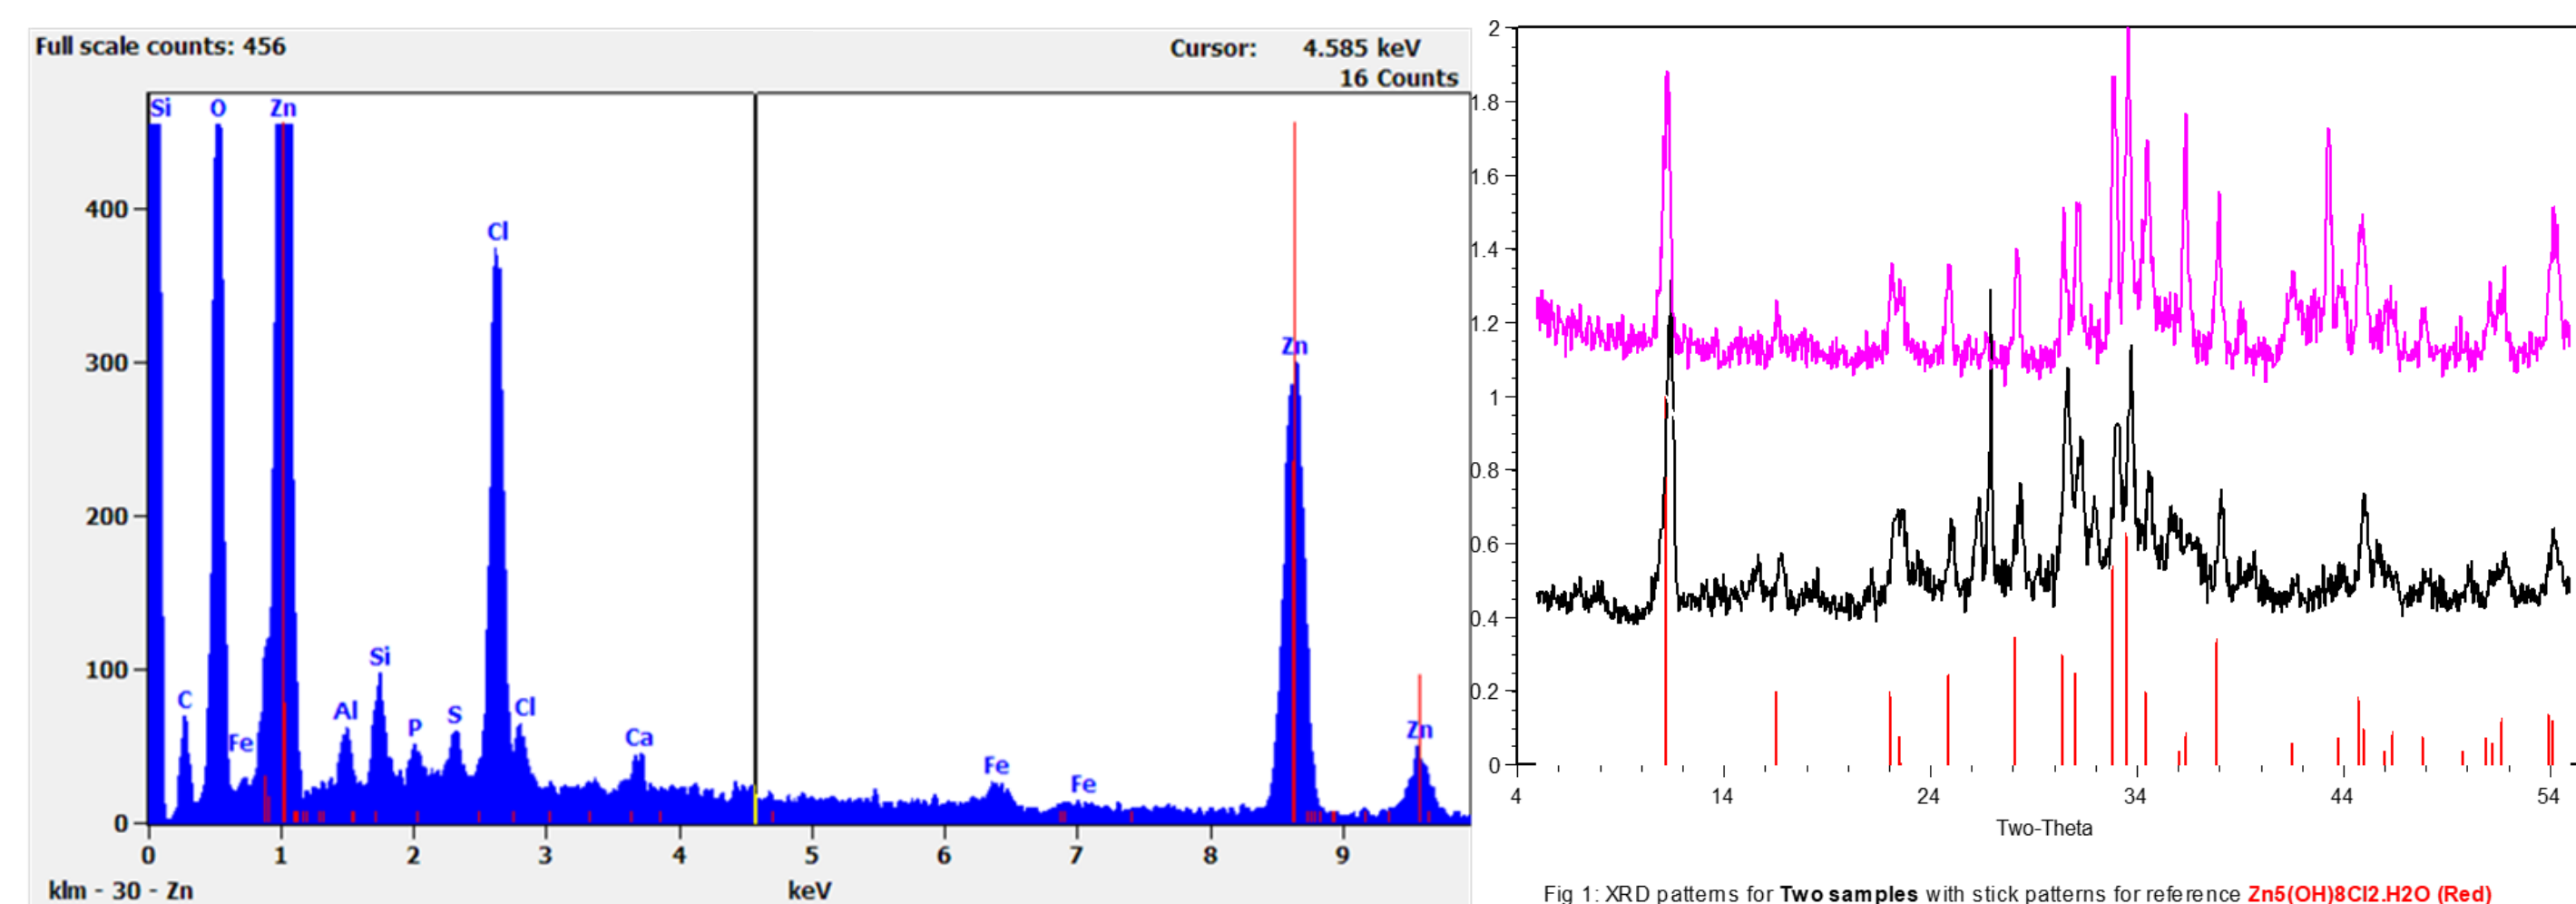
Tower Section Fasteners - Structural

Problem — Corrosion observed on structural fasteners <1 year post installation.

Cause — Chloride salt ingress prior to installation lead to accelerated corrosion within flange.

Solution — Improve hardware tracking and remove salt residues prior to installation.

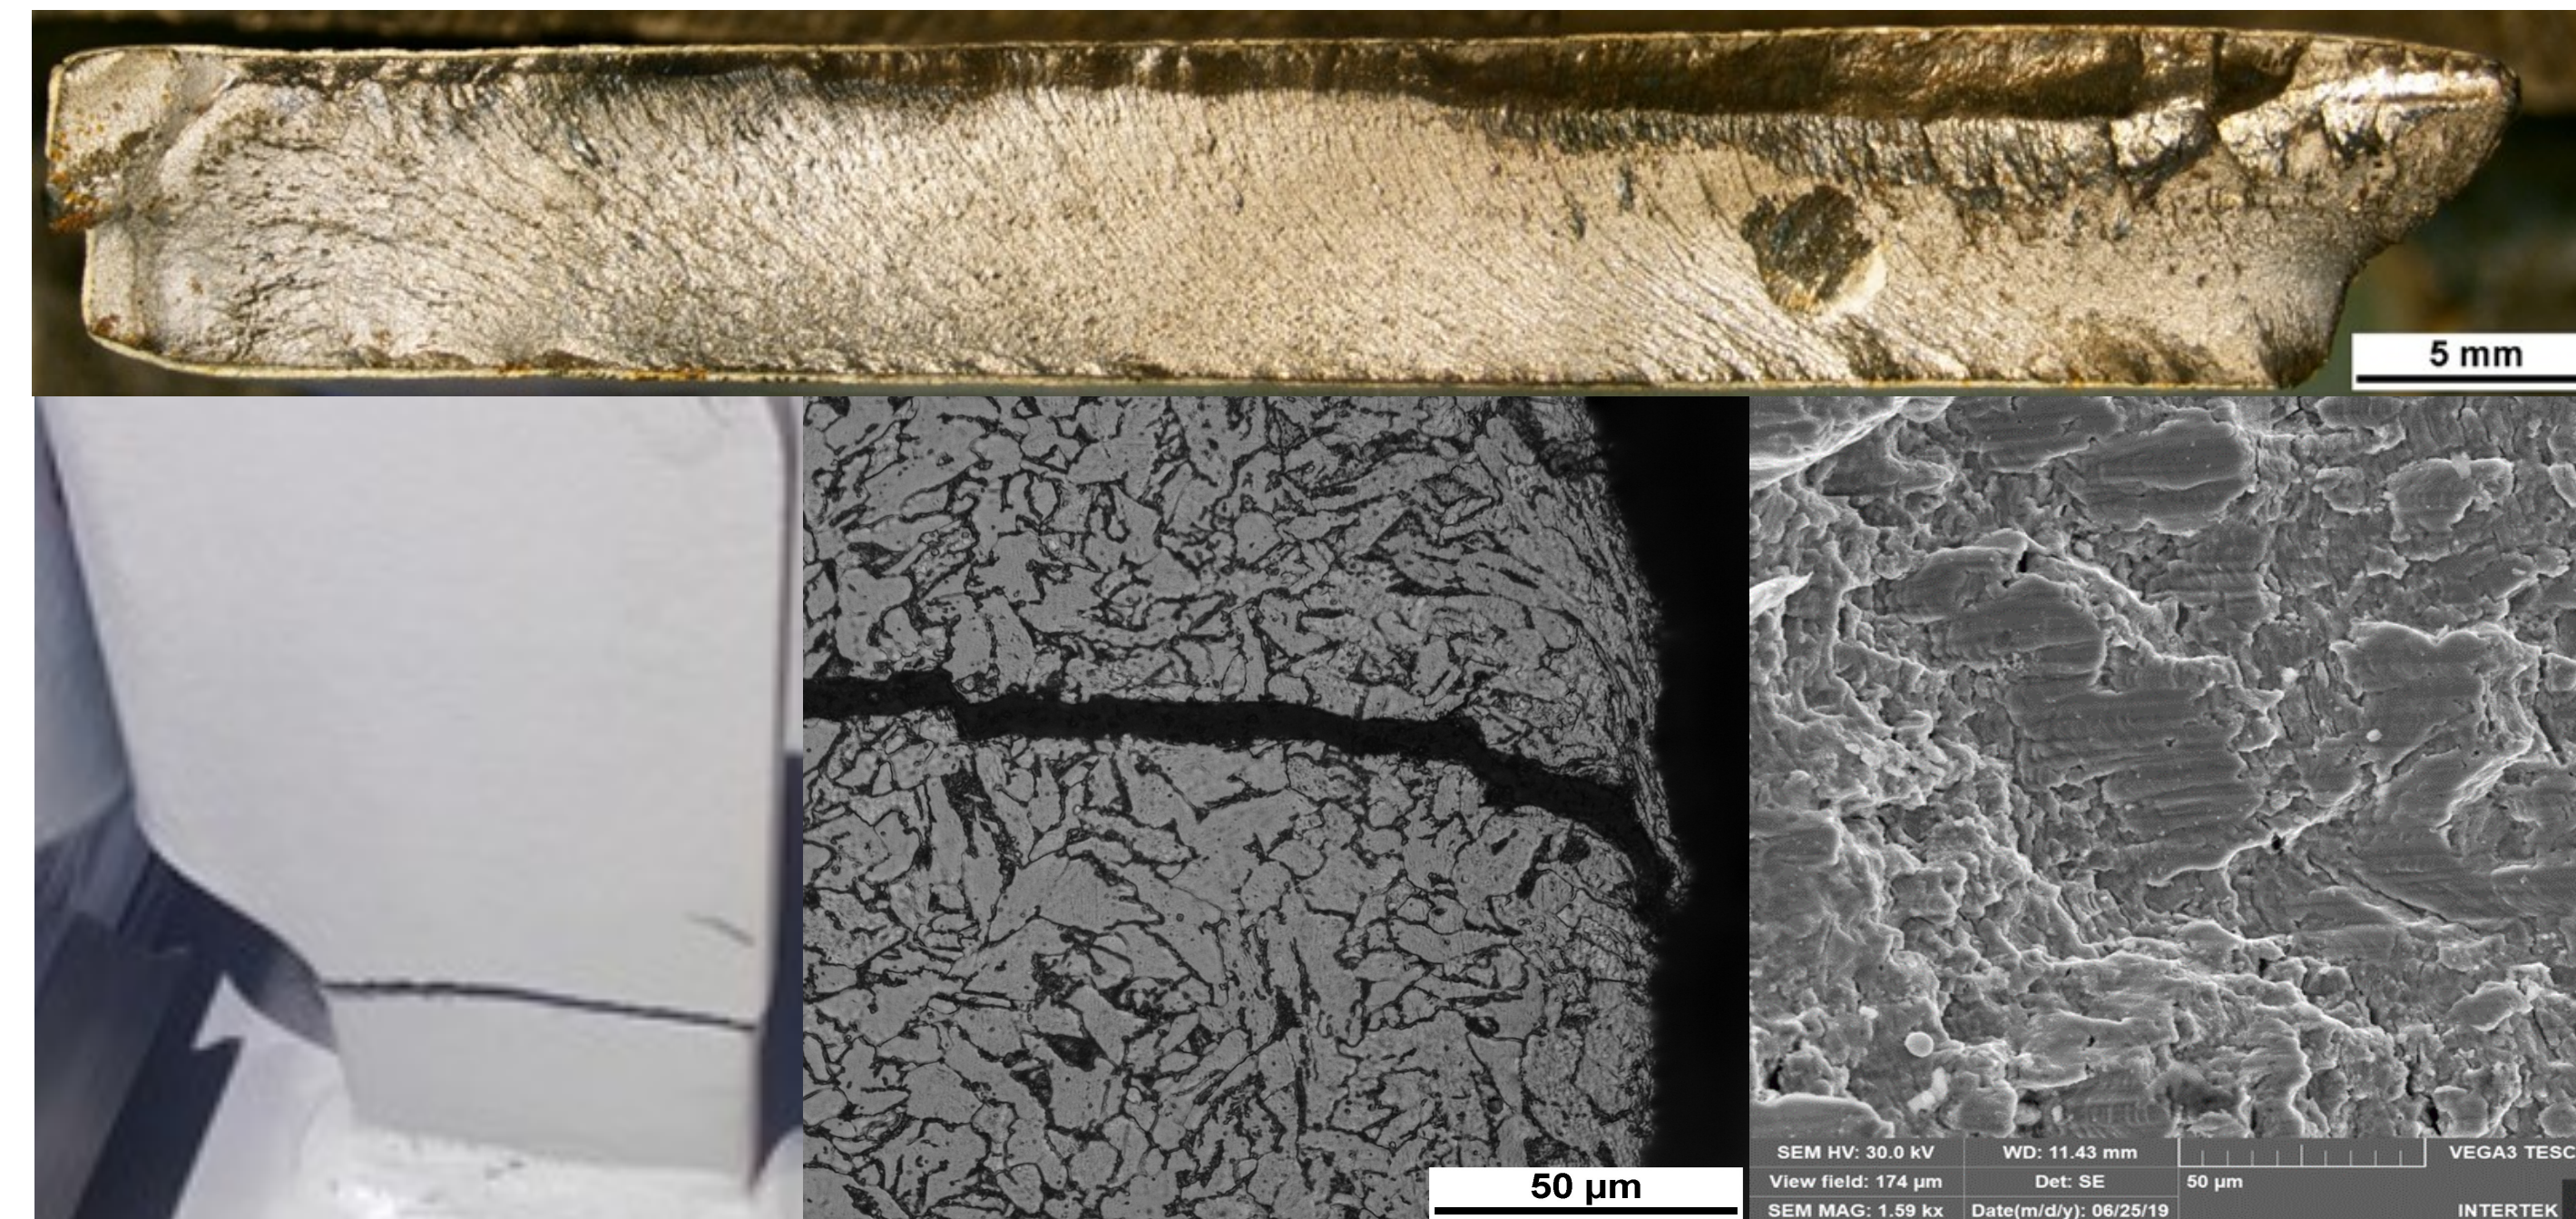
Platform Bracket – Ancillary Structural

Problem — Broken tower platform lugs prior to service life.

Cause — High-cycle fatigue during overseas transport from harmonic amplification of vibration in 3rd tower section.

Solution — Add rubber blocks/vibration dampeners during shipping.

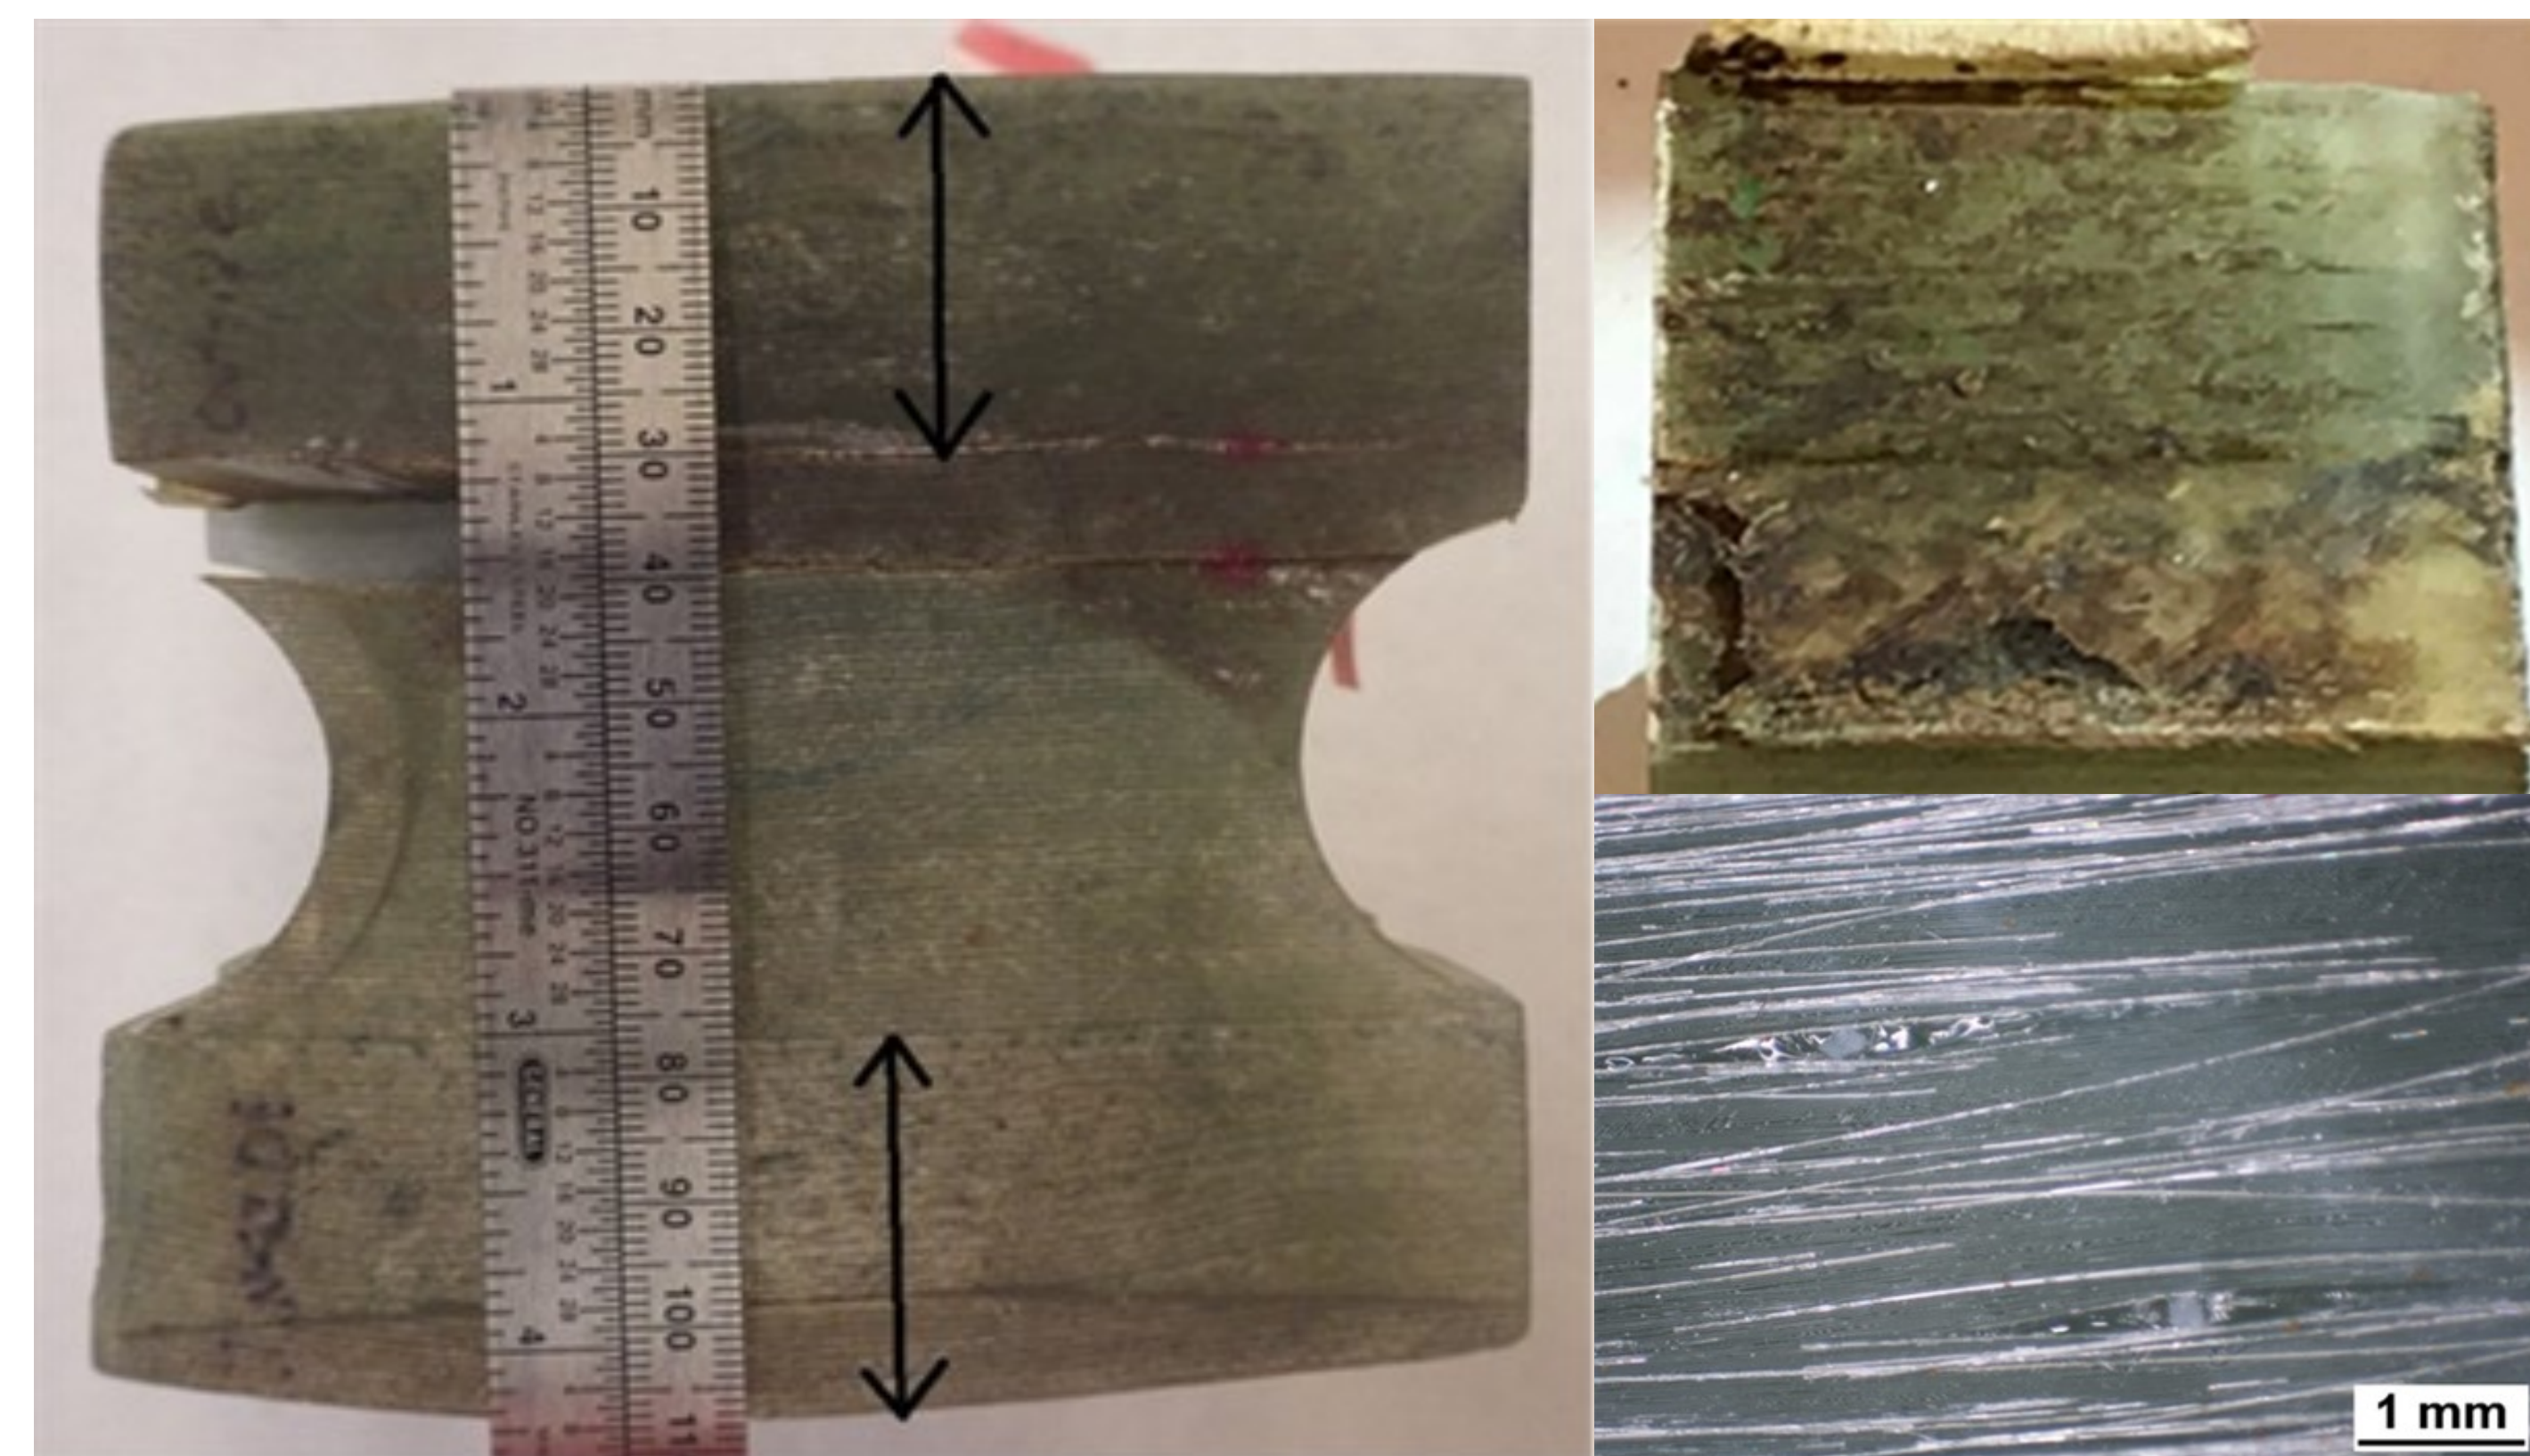
Fiberglass Blade Support Section – Drivetrain

Problem — Cracked blade root support pin after 20,000 hours service life.

Cause — Grease ingress from bearing over-lubrication lead to delamination cracking, initiated within allowable microvoids in fiberglass.

Solution — Examine grease records and inspect blade adapter root region in high grease consumption units.

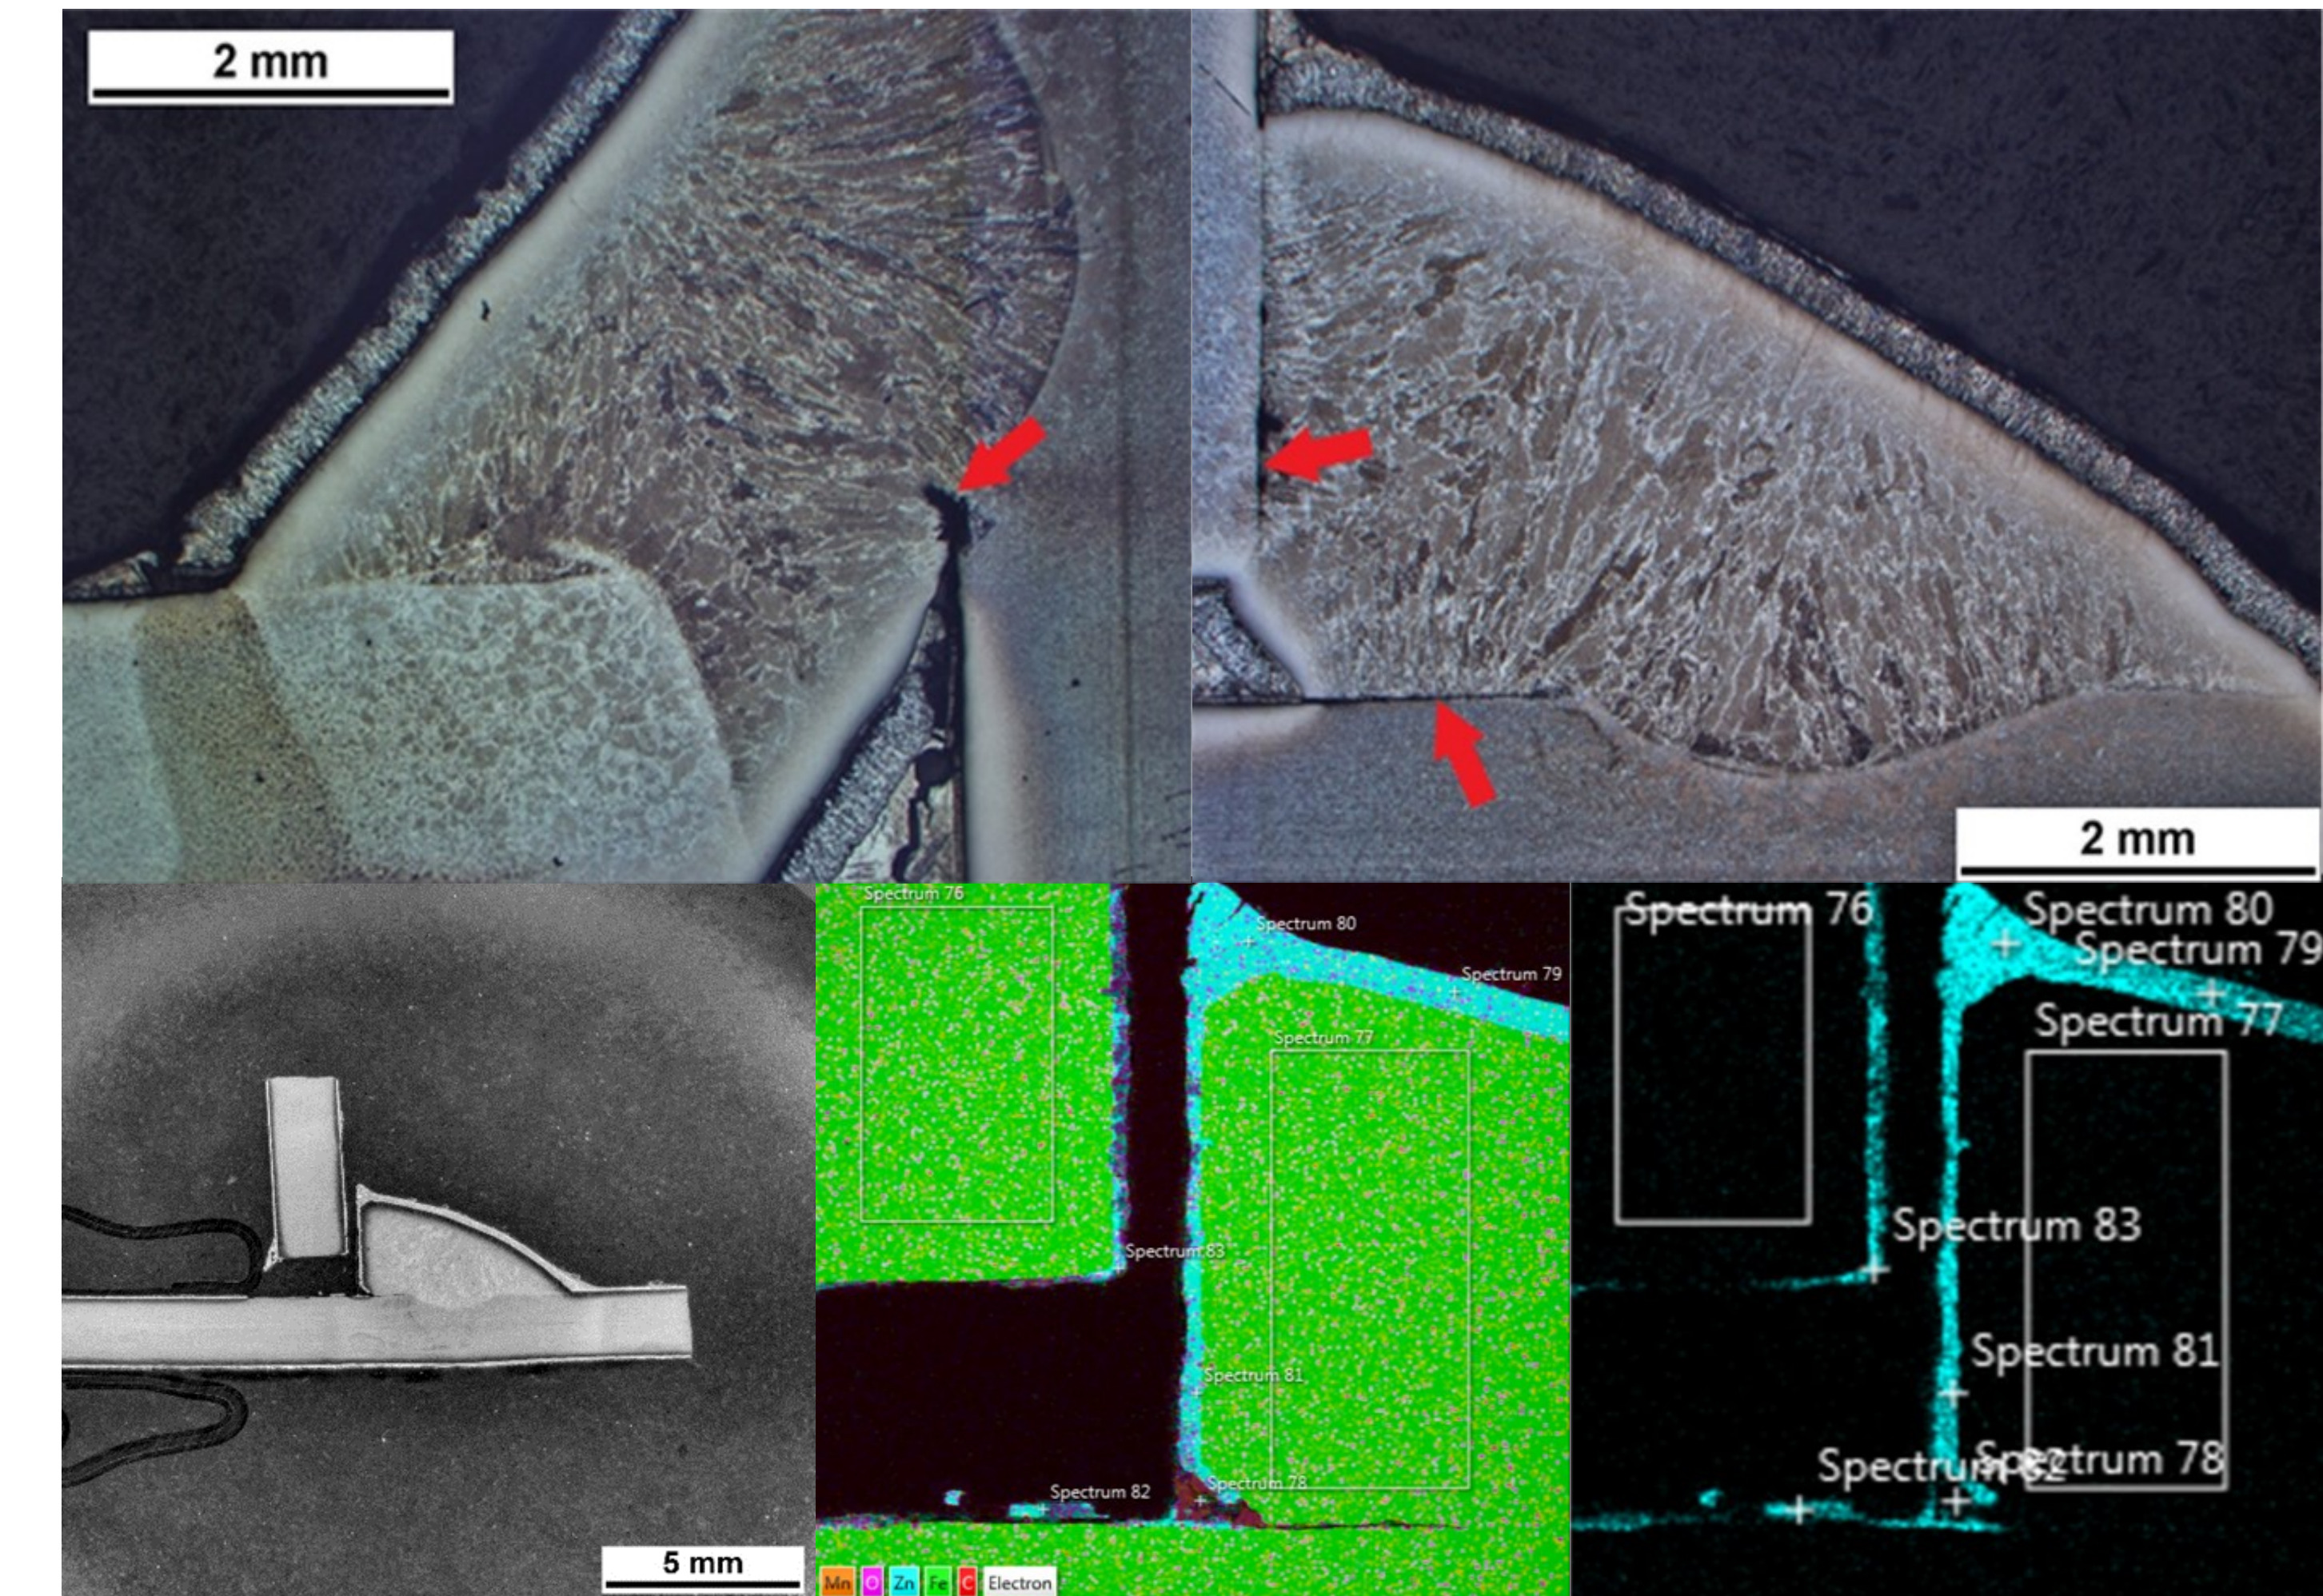
Ladder Rung – Ancillary Safety

Problem — Frequent early-life ladder rung failure at rung to siderail weld.

Cause — Welding process defects and insufficient quality control resulted in lack of fusion. Resulting reduced cross section fractured prematurely.

Solution — Operator to screen with magnetic particle testing, manufacturer to revise welding and quality control processes.
